Bureau of Mines Information Circular/1987

## **Hose Safety During High-Pressure Water-Jet Cutting**

By C. D. Taylor, J. L. Thompson, H. J. Handewith,  
and E. D. Thimons

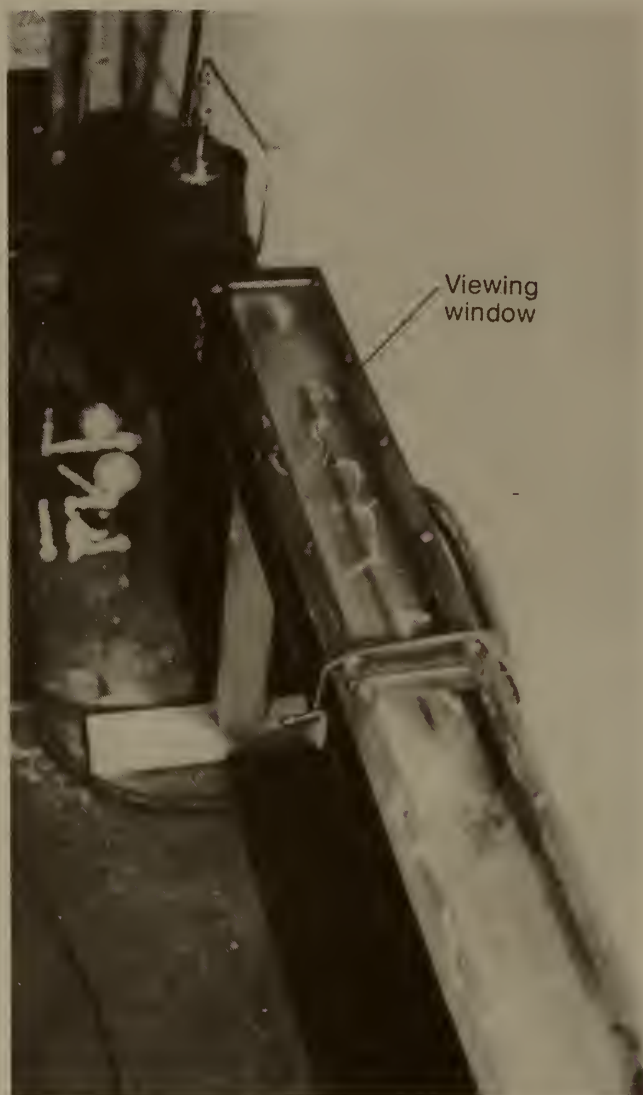
FIGURE 2.—Hose containment area.

For burst testing, the Bureau used a hose burst test fixture that was designed and fabricated by a commercial firm for routine quality testing of high-pressure water hoses. The test unit consists of hinged steel channel sections locked together to create a safe pressure containment area for bursting hoses. An insert of clear rigid plastic in the top channel facilitates viewing (fig. 2). The high-pressure water is generated by an intensifier with a 47:1 water-to-oil pressure ratio (fig.3). For safety, the intensifier is located at the end of the test unit, inside a steel cylinder.

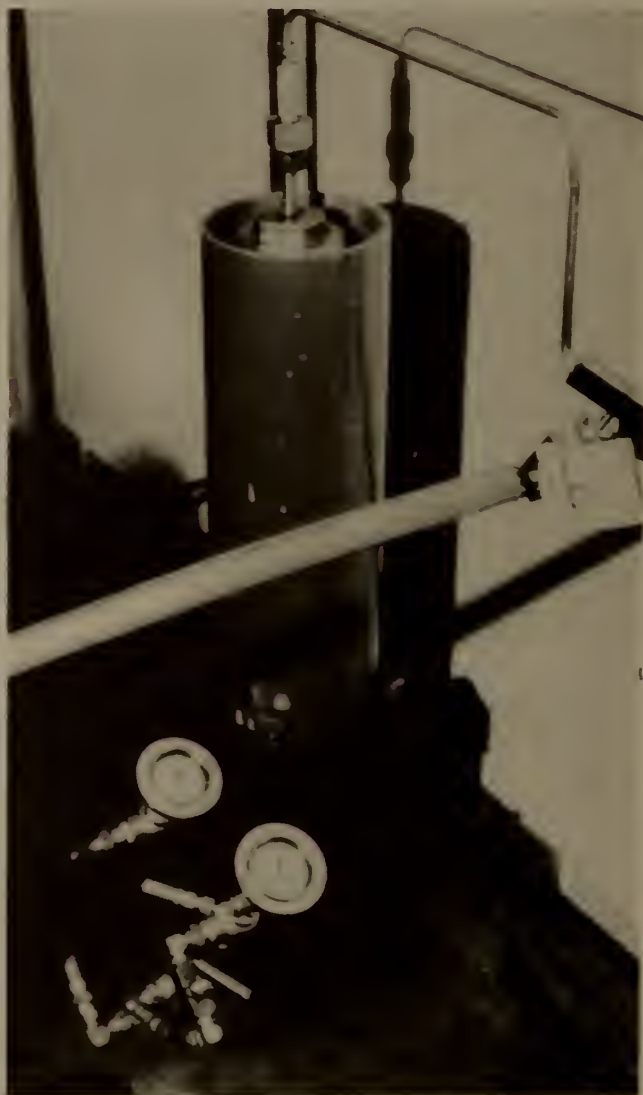
FIGURE 3.—Intensifier used for burst tests.

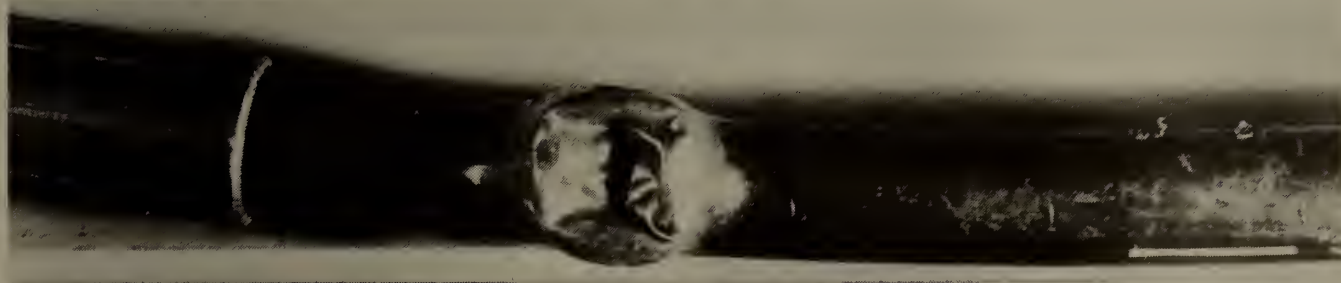
FIGURE 4.—Noncatastrophic hose failure.

All of the hoses that failed during the fatigue tests failed in a noncatastrophic manner; the inner liner broke, and water was forced slowly through the wire reinforcement, causing a bubble to form inside the plastic outer covering (fig. 4). Post-test inspections of these hoses showed that the wire reinforcement was not damaged, but that the inner liner had failed. Hoses that did not fail during fatigue testing were subsequently burst tested. These hose samples did not show significant reduction in actual burst pressures, suggesting that fatigue testing did not weaken the wire reinforcement.
